EXECUTIVE SUMMARY
AIRCRAFT ACCIDENT INVESTIGATION
F-16 CG, S/N 90-0776
524TH EXPEDITIONARY FIGHTER SQUADRON (EFS), BALAD AB, IRAQ
27 NOVEMBER 2006

F-16CG, S/N 90-0776, 27 November 2006

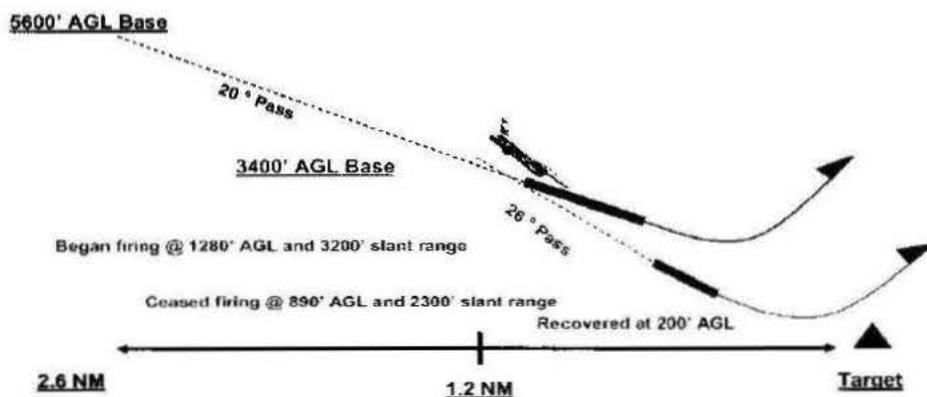
1st Attack Parameters

At 1330L, MP successfully identified two enemy trucks with passengers and weapons in the back and at 1331:30L rolled in for his first of two strafe passes to strafe the lead truck. (Tab EE-11.1) His aircraft parameters at his base position prior to roll-in were 3400' AGL and 380 knots indicated airspeed (KIAS), 1.2 nautical miles (nm) from the target. (Tabs EE-1.1, DD-1.1) His aircraft parameters at employment were 26 degrees nose low at 440 KIAS. He squeezed the trigger at 1280' above ground level (AGL) at 3200' slant range and released the trigger at 890' AGL and 2300' slant range (Tabs J-9, DD-1.1, EE-1.1)

During the first strafe pass, MP received predictive ground collision avoidance system (PGCAS) initiated warnings in his multi-function displays (MFDs) approximately 2 seconds prior to employing the gun. MP also received PGCAS warnings in his

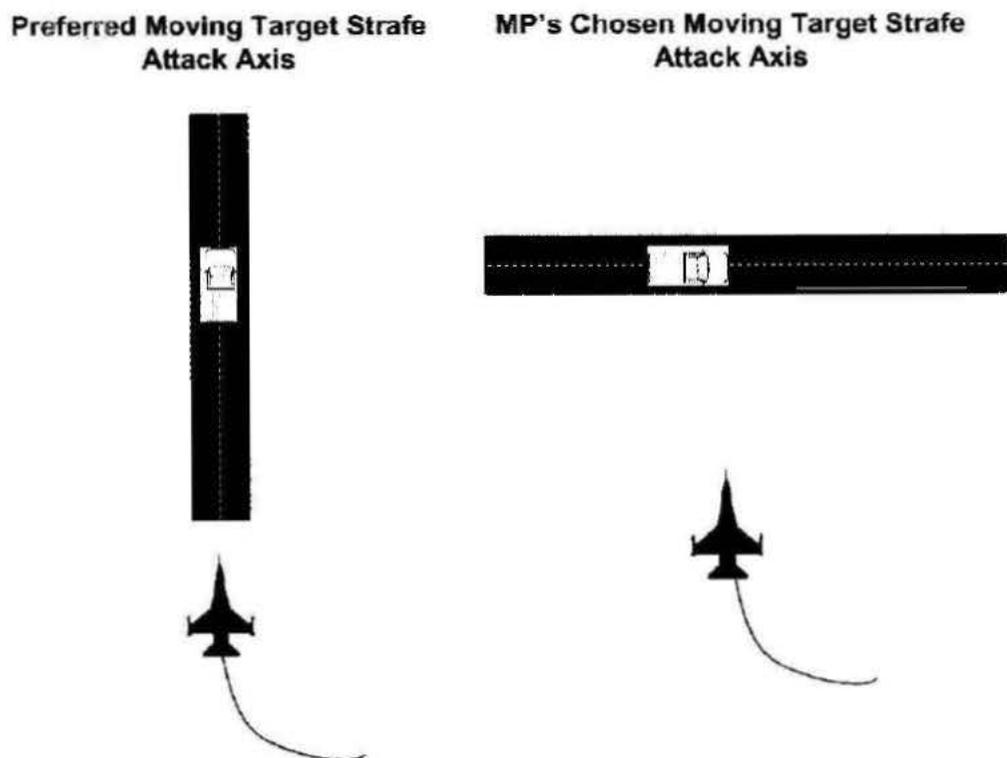
Additionally, conducting a strafe attack against a moving target is dramatically more difficult than a static target. When a target is moving, a pilot must fire in front to ensure the bullets hit the intended target while both are traveling considerable distances. Moving target strafe is preferably performed flying as parallel to the moving target's path as possible since there will be minimal relative motion between the aircraft and the target. The least desirable approach is perpendicular to the target's path of travel as it requires the most continuous correction of the aircraft's aim point and hence the most concentration. Perpendicular strafing of moving targets is not routinely practiced or recommended. (Tab V-18.5) Excessive motivation to succeed may have resulted in the

MP's decision to attack perpendicular to the moving target's path, further complicating his attack. The following diagram depicts the preferred attack axis on the left and the MP's attack axis on the right.

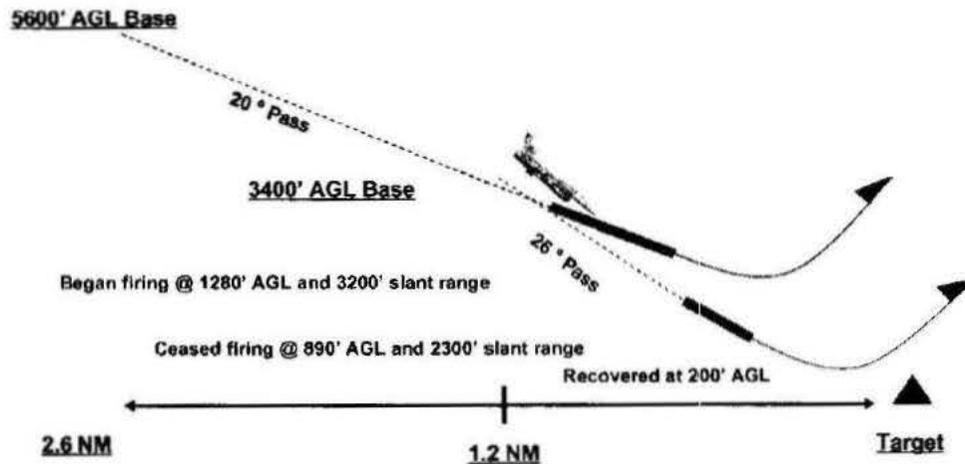
1st Attack Parameters

f. During the MP's first pass, he began the attack well below and far too close to his intended target resulting in a dive angle which was 6 degrees steeper than planned. This can be seen in the following diagram.

g. It is my opinion that the MP arrived at these parameters due to channelized attention manifested by his desire to maintain 100% positive visual identification on the moving vehicles. There is no indication the MP was using any sensor other than his eyes to find, fix, track, and attack the enemy. I came to this opinion following thorough review of the MP's tapes, flight in a T-38 where I was able to recreate the conditions of the MP's attack prior to roll in on the target, and flight in an F-16 simulator at Luke AFB, AZ, where I was able to safely recreate the MA flight profile through to ground impact on the last strafe pass.

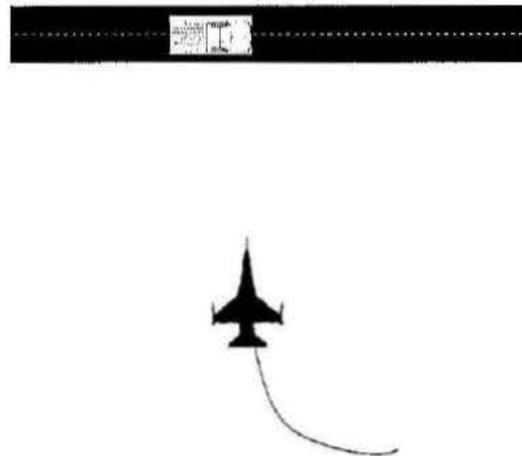
**MP's Chosen Moving Target Strafe
Attack Axis**

i. It is my opinion that the MP had excessive motivation to succeed such that, in order to engage the enemy immediately, caused him to choose the most difficult possible attack axis in reference to enemy vehicle movement after he established PID and received clearance from the JTAC. All academic preparation, his flying spin-up, and his pre-flight briefing emphasized a preferred attack axis down the road thereby minimizing line of sight movement when shooting the 20 MM gun. The MP was operating in a dynamic combat environment where friendly troops were initially under attack at the start of his

working period. The JTAC was under fire and asked for immediate help to subdue and/or deter the enemy from further attacks. The following drawings exhibit the preferred attack axis on the left and the MP's attack axis on the right.
