EXECUTIVE SUMMARY
AIRCRAFT ACCIDENT INVESTIGATION
F-16 CG, S/N 90-0776
524TH EXPEDITIONARY FIGHTER SQUADRON (EFS), BALAD AB, IRAQ
27 NOVEMBER 2006

F-16CG, S/N 90-0776, 27 November 2006

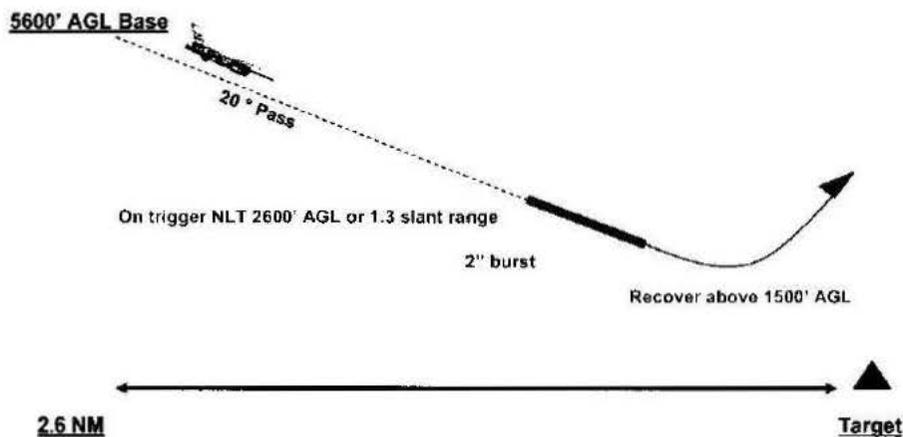
Planned/Briefed 20° High Angle Strafe Attack

The parameters the MP flight stepped to fly with for a high angle strafe pass are pictured in the following diagram. The attack is designed to achieve desired weapons effects and safely recover above 1500' AGL.

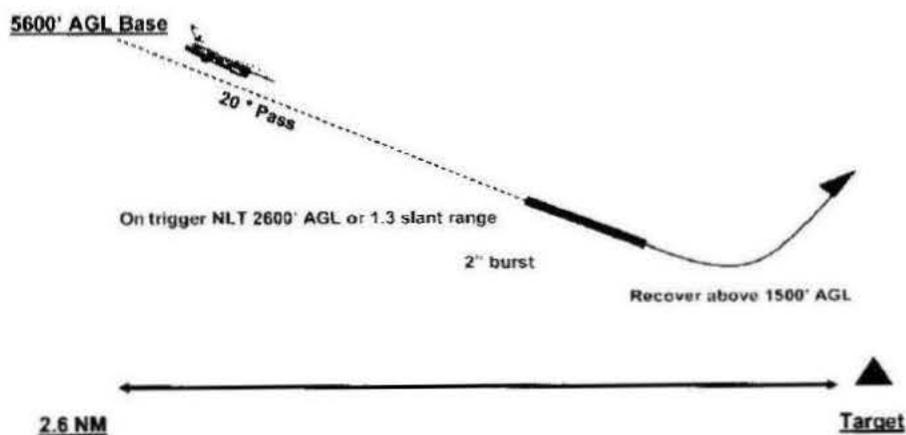
Planned/Briefed 20° High Angle Strafe Attack

e. The parameters the MP flight stepped to fly with for a high angle strafe pass can be pictured in the following diagram. High angle is defined as any dive angle above 15 degrees. The attack is designed to achieve desired weapons effects and safely recover above 1500' AGL.

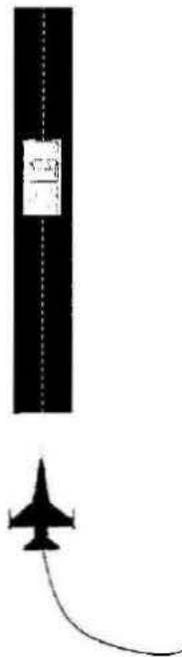
**Preferred Moving Target Strafe
Attack Axis**

working period. The JTAC was under fire and asked for immediate help to subdue and/or deter the enemy from further attacks. The following drawings exhibit the preferred attack axis on the left and the MP's attack axis on the right.
